FLYING V PROPERTY INSPECTIONS

1234 Main Street  
La Vernia TX 78121

08/18/2026 9:00AM

# PROPERTY INSPECTION REPORT FORM

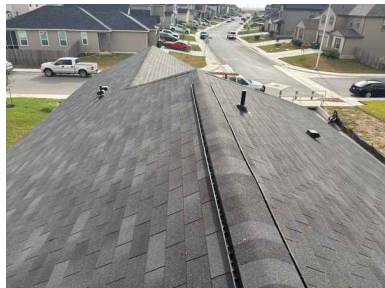
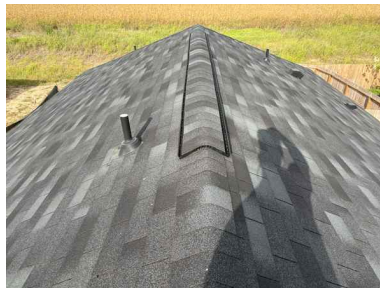
Left side roof face

### 1: Shingle penetration

Shingle has a penetration. Recommend correction.

Recommendation: Contact a qualified professional.

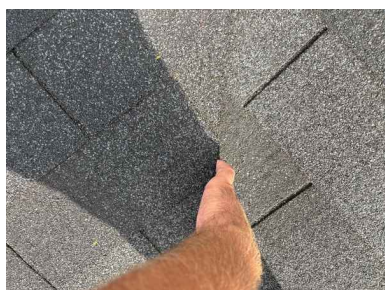
Front Valley

### 2: Valley shingles not sealed

Recommend sealant to mitigate wind damage

Recommendation: Contact a qualified professional.

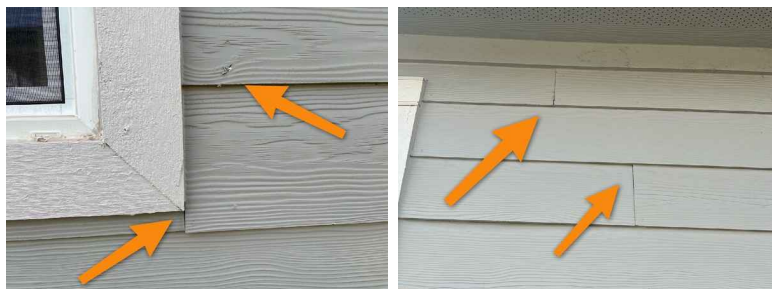
Right side

**1: Exterior joint/penetration(s) not sealed correctly**

Joint/penetration(s) are not sealed correctly in one or more areas. Recommend correction.

Recommendation: Contact a qualified professional.

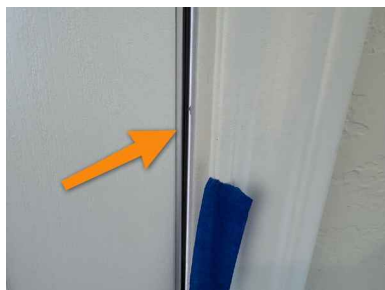
Rear exterior door

**1: Light visible in exterior door weather stripping**[🔧 Maintenance Item](#)

There's light visible through the exterior door weatherstripping. This can lower efficiency. Recommend weatherstrip or door adjustment.

Recommendation: Contact a qualified professional.

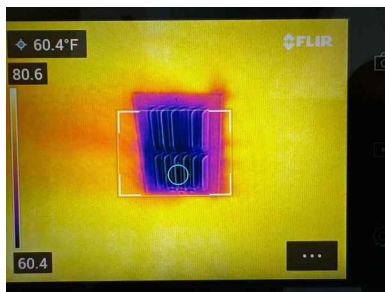
During cooling test, the temperature split was noted to be 15.9°F. This is negative of a properly functioning unit. TREC has stated that an acceptable split for home inspection purposes is 15 to 22°F. It does not guarantee future performance.

60.4 at supply

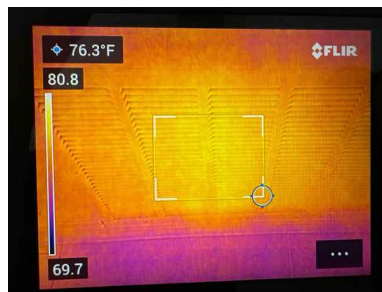
76.3 at return

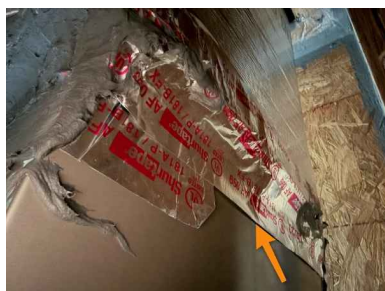
Backside of HVAC supply Plenum

**1: Duct Leaking**

Air supply duct was leaking air. Recommend a qualified HVAC technician or vents &amp; ducts contractor repair.

Recommendation: Contact a qualified HVAC professional.

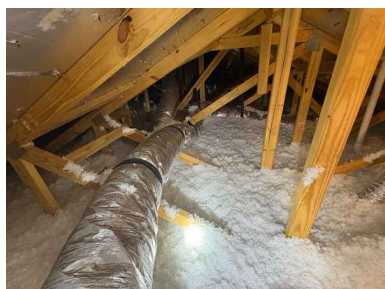
Fresh air makeup unit ductwork

**2: Fresh air makeup**

Fresh air make up vent to front two bedrooms and hallway. Fresh air makeup unit also set to 26 minutes. Not best practice. Recommend verifying duct plans.

Recommendation: Contact a qualified professional.

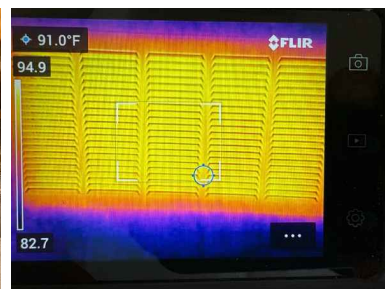
Example of fresh air makeup unit temperature reading at front hallway

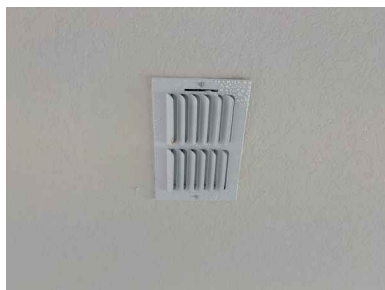
**3: Ductwork Creating condensation middle entertainment room**

Recommend further evaluation. Condensation on registers can be created from humidity indoors or indicative of a sign of a duct leak.

Recommendation: Contact a qualified professional.

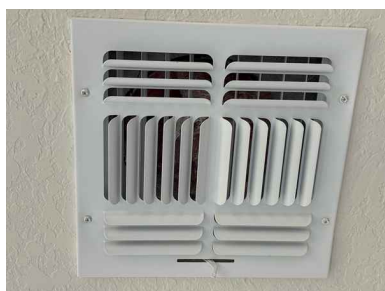
Kitchen/living area

#### 4: Some registers are not cooling/obstructions

Some registers in the home did not have airflow or had obstructions visible at register. Recommend correction.

Recommendation: Contact a qualified professional.

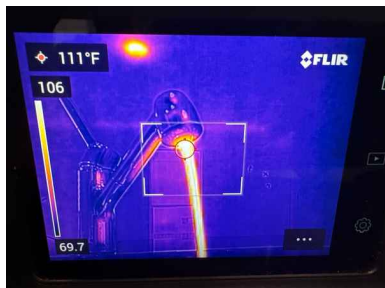
111 F at kitchen sink

See photo for water temperature measurement at kitchen sink. It is recommended to keep the temperature between 120 and 130 to prevent growth of legionella bacteria and to limit Scull hazards. Adjust thermostat to suitable temperature, as desired. FYI for safety: water temperature should not exceed 130° F at any fixture.

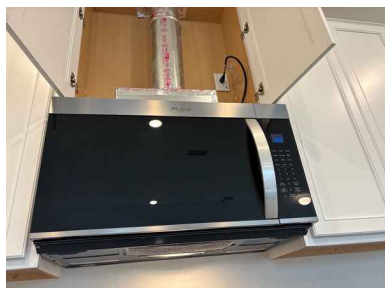
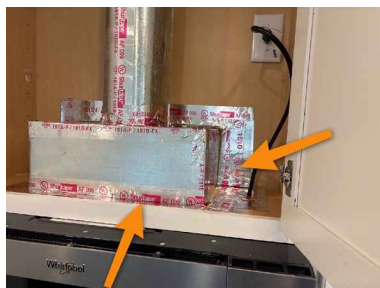
#### 1: Exhaust Leaks into House

Exhaust leaks into house. Recommend a qualified professional to correct.

Recommendation: Contact a qualified professional.

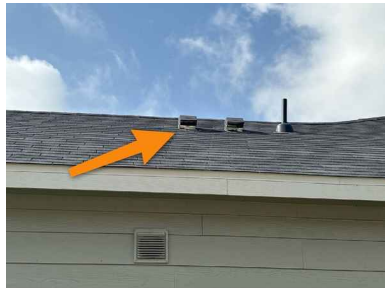
Dryer vent – right side

**1: Dryer vent is screened****🔴Recommendation**

Dryer exhaust discharge has a screen installed. This is improper As no barrier should be installed as lint can buildup on screen and become clogged. Recommend builder to remove screen and ensure the damper works properly.

Recommendation: Contact a qualified professional.

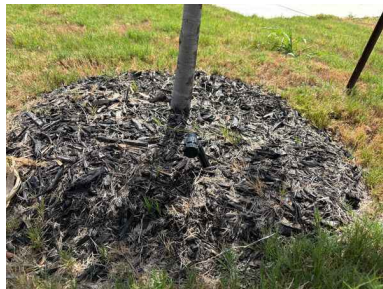
Low water pressure observed. Recommend examining the backflow device to make sure valve is turned completely on.

Recommendation: Contact a qualified professional.

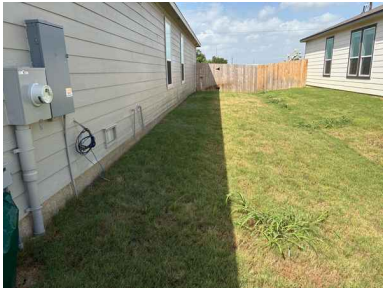
#### 2: Redirect Sprinkler Heads Spraying on Structure

The water spray from the sprinkler system should be re-directed away from the structure and/or any fencing, decks, etc., to decrease the possibility of damage. Observed in zones: 6

Recommendation: Contact a qualified professional.

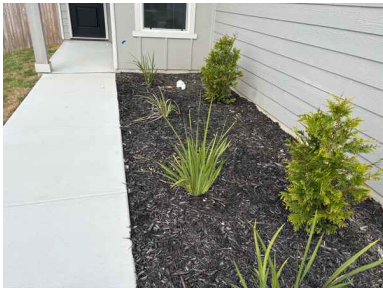
**3: Exposed drip line**

Recommend covering drip line to prevent UV and frost damage.

Recommendation: Contact a qualified professional.
