FLYING V PROPERTY INSPECTIONS

1234 Main Street  
La Vernia TX 78121

# PROPERTY INSPECTION REPORT FORM

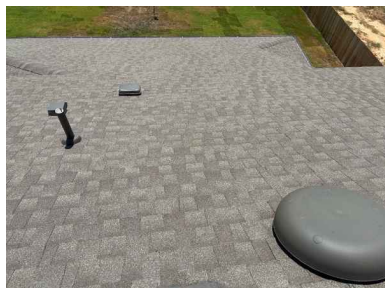
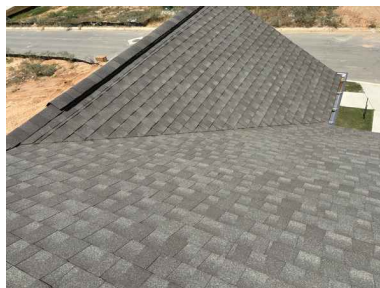
## 1: Damaged Coverings/ exposed nails

Roof coverings exhibited general damage and scarring that could affect performance some with nails penetrated through or exposed. Recommend a qualified roofer evaluate and repair.

Recommendation: Contact a qualified roofing professional.

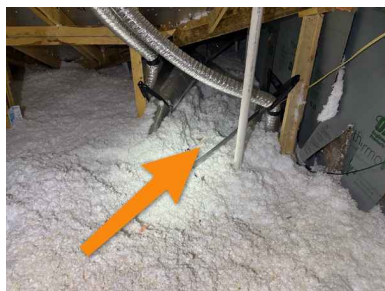
Lower left and right side Attic

**1: Disturbed Insulation**

Some portions of the attic had lower levels of insulation in areas that had been disturbed from previous maintenance.

Recommendation: Contact a qualified professional.

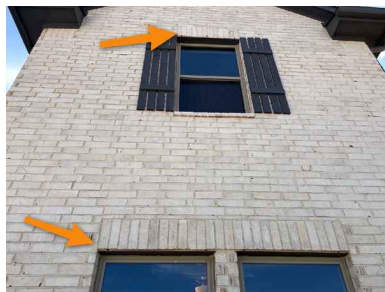
Front

**1: Exposed/Rusty Lentils****🔴Recommendation**

Lentils are a support feature in masonry applications. Exposure to the elements can cause swelling from rust, which can lead to cracks. Recommend a qualified professional.

Recommendation: Contact a qualified professional.

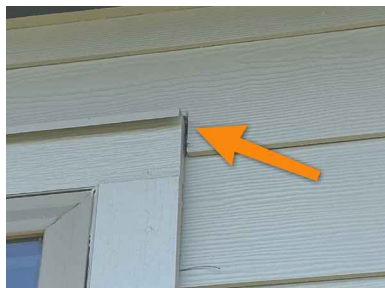
Rear

**2: Exterior joint/penetration(s) not sealed correctly****🔴Recommendation**

Joint/penetration(s) are not sealed correctly in one or more areas. Recommend correction.

Recommendation: Contact a qualified professional.

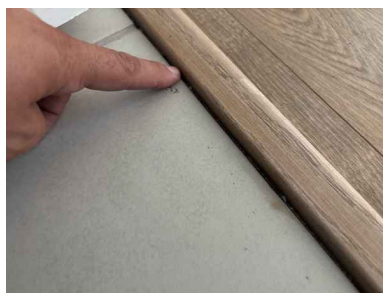
Half bathroom

**1: Missing Grout**

Grout was missing at the tile vinyl transition at the half bathroom. Recommend correction.

Recommendation: Contact a qualified professional.

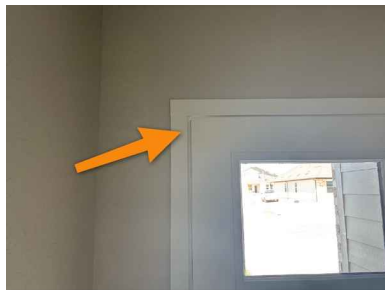
Front exterior

**1: Doors Need Adjustment**

Doors rub, hit frame, or needs adjustment. Recommend adjustment as needed. Observed in multiple doors throughout the home such as :

Recommendation: Contact a qualified door repair/installation contractor.

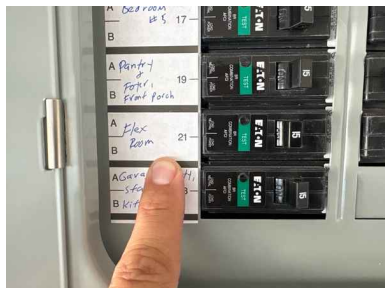
#### **1: Breaker found tripped at time of inspection, not fully inspected**

Recommend verifying functionality before close

Recommendation: Contact a qualified professional.

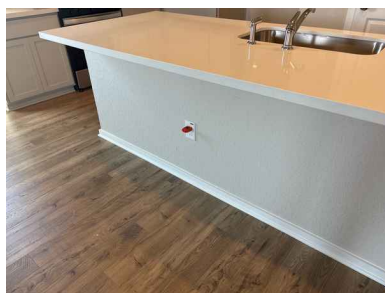
*No significant damage/issues at the time of inspection :***1: Observation: Kitchen island receptacles****⚠️Recommendation**

210.52(C)(3) - Receptacles New: Receptacles serving the kitchen countertop are no longer allowed to be located below the work surface. All receptacles required for the kitchen counter space must be located above the surface, or else be approved counter-mounted or pop-up receptacles. NEC (National Electrical Code). Recommend verifying local requirements for this electrical code.

Recommendation: Contact a qualified professional.

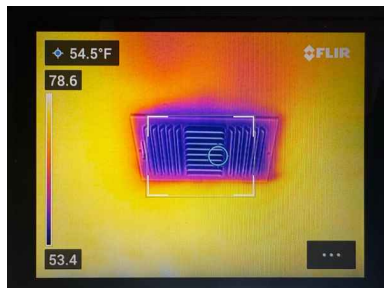
54.5°F at supply

During cooling test, the temperature split was noted to be 19.3°F. This is negative of a properly functioning unit. TREC has stated that an acceptable split for home inspection purposes is 15 to 22°F. It does not guarantee future performance.

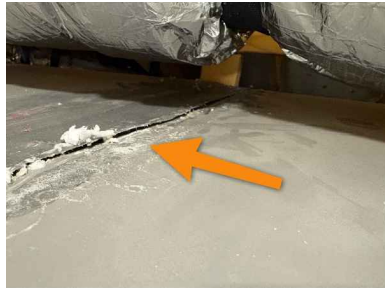
Supply Plenum connection

**1: Duct Leaking**

Air supply duct was leaking air. Recommend a qualified HVAC technician or vents & ducts contractor repair.

Recommendation: Contact a qualified HVAC professional.

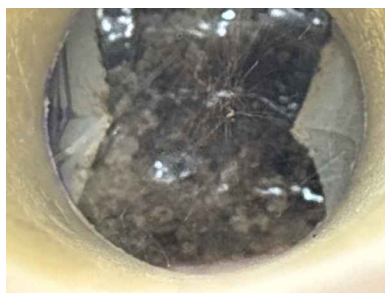
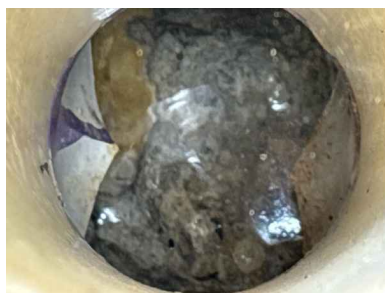
### 1: Construction debris in drain lines

Recommend clearing and correction

Recommendation: Contact a qualified professional.

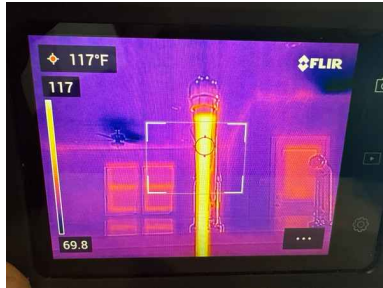
117°F at kitchen sink

See photo for water temperature measured at kitchen sink. It is recommended to set the temperature to know more than 130°F to limit scald hazards.

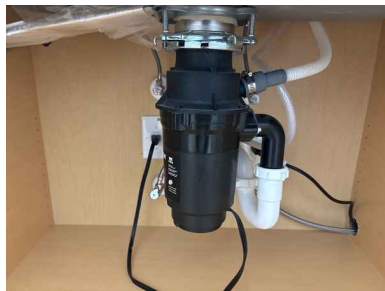
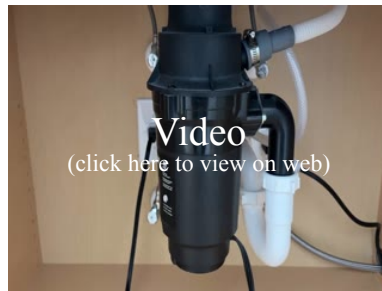
#### 1: Excessive Noise

Garbage disposal was excessively noisy. Recommend a qualified plumber evaluate and repair.

Recommendation: Contact a qualified handyman.

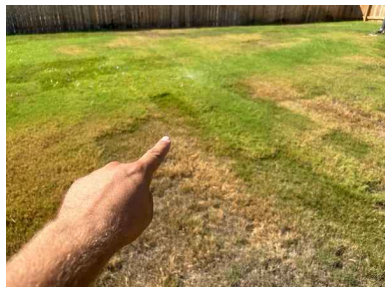
Zone three

## 2: Damaged head

Recommendation: Contact a qualified professional.

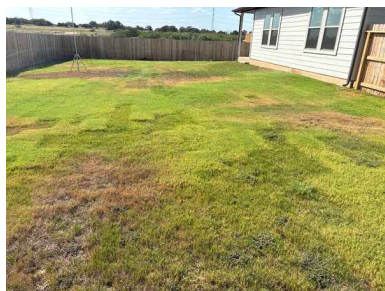
## 3: Some sod has not taken due to in adequate coverage from head, needing adjustment or damaged heads not providing adequate coverage

Recommendation: Contact a qualified professional.
