FLYING V PROPERTY INSPECTIONS

1234 Main Street  
La Vernia TX 78121

11/18/2025 9:00AM

# PROPERTY INSPECTION REPORT FORM

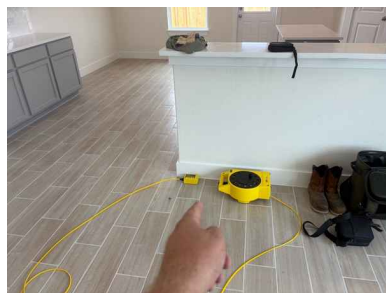
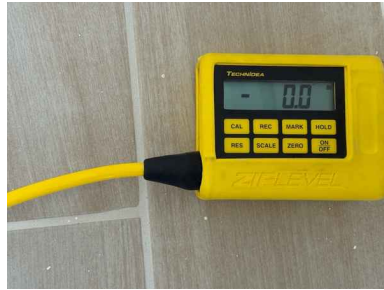
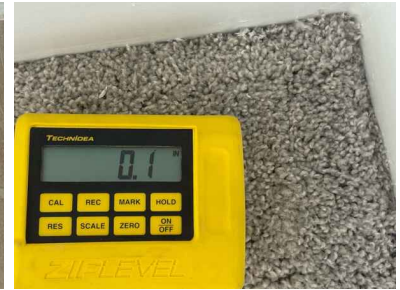
Zero Location

Random elevations using a ZipLevel Pro 2000 were taken. We did not find any concerns with slope or deflection. The foundation appears to be performing as intended.

In this inspector's opinion the foundation was performing as designed at the time of inspection. There were minor indications of settlement. There was no noticeable movement noted in the accessible attic space of this structure.

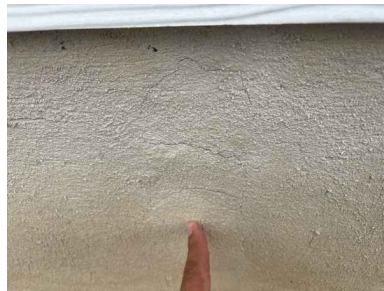
### 1: Cracking at the exterior parging plaster coat

Left side

This condition is common in many homes and does not usually represent a structural concern. In an effort to prevent long-term or further deterioration, it would be wise to consider patching any deteriorated and cracked areas.

Recommendation: Contact a qualified concrete contractor.

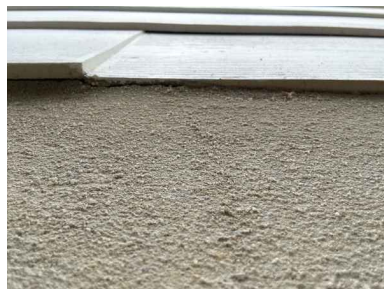
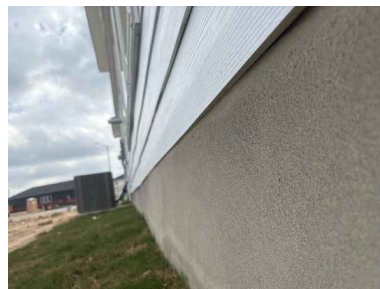
Parging/plaster coat is in direct contact and or clogs lap siding. There should be an open space between the siding and foundation to allow air to flow and moisture to move out of the wall space.

Recommendation: Contact a qualified professional.

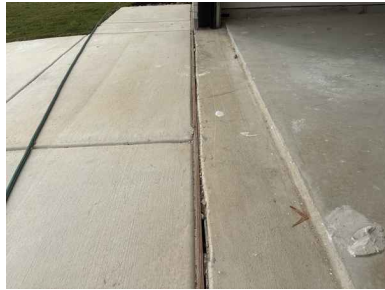
**2: Negative Grading****Recommendation**

Grading is sloping towards the home in some areas. This could lead to water intrusion and foundation issues. Recommend qualified landscaper or foundation contractor regrade so water flows away from home.

Recommendation: Contact a qualified landscaping contractor

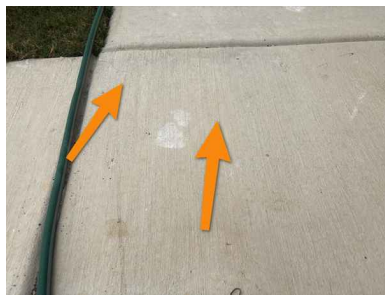
#### 4: Minor cracks and flat work

Recommendation: Contact a qualified professional.

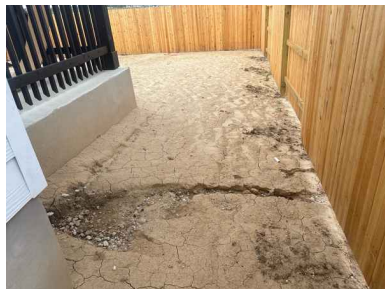
#### 5: No sod in rear/ soil washing at drip edge

Recommendation: Contact a qualified professional.

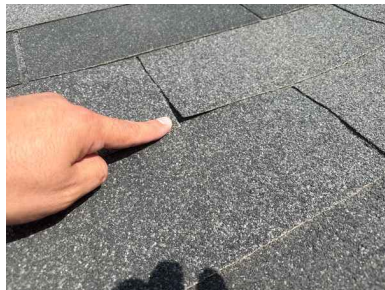
#### 1: Lifted shingles

Lifted shingles are present on the roof. They are not properly adhered to the roof leaving them susceptible to high winds.

Recommendation: Contact a qualified roofing professional.

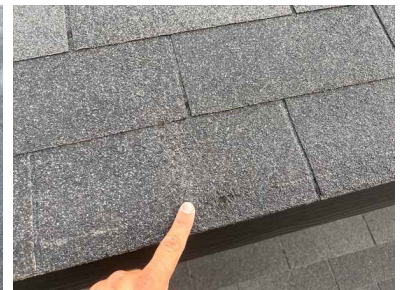
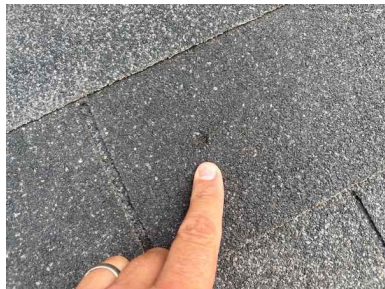
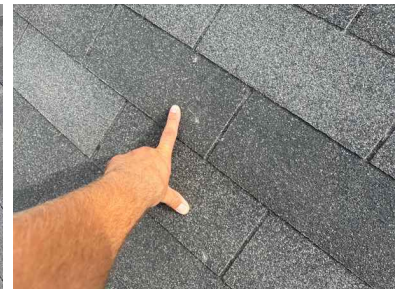
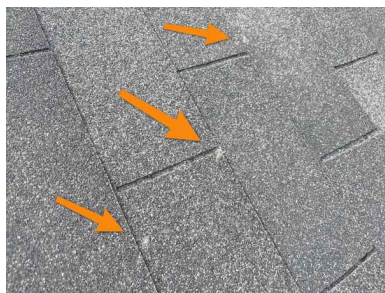
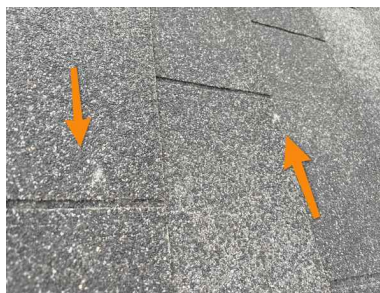
## 2: Damaged Coverings

Roof coverings exhibited general damage and scarring that could affect performance. Recommend a qualified roofer repair.

Recommendation: Contact a qualified roofing professional.

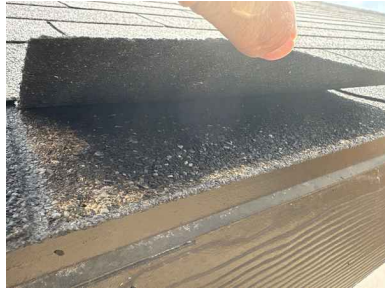
## 3: No starter strip on first course of shingles

No starter strip adhesive on the first course of shingles can leave shingles prone to high wind damage. Recommend a qualified professional to correct.

Recommendation: Contact a qualified professional.

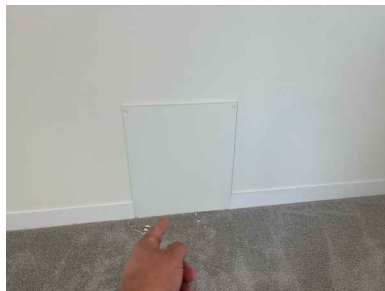
*Rear attic access blocked:*

The attic access to the rear portion of the home was not accessible due to access being blocked.

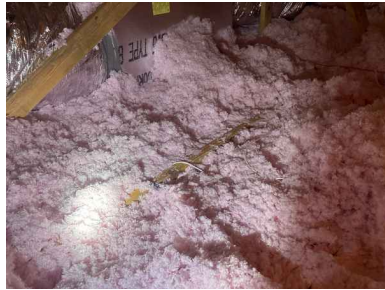
**1: Disturbed Insulation**

Some portions of the attic had lower levels of insulation in areas that had been disturbed from previous maintenance.

Recommendation: Contact a qualified professional.

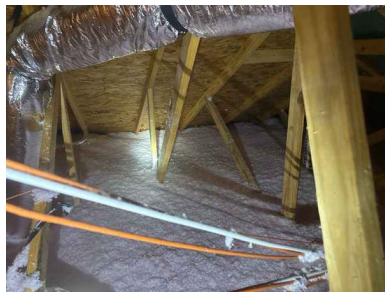
## 2: Missing baffles

Baffles create a space for input ventilation, or in this case, soffit ventilation air to flow into the attic and out through the top. Without them airflow can be blocked by insulation. Recommend installing baffles.

Recommendation: Contact a qualified professional.

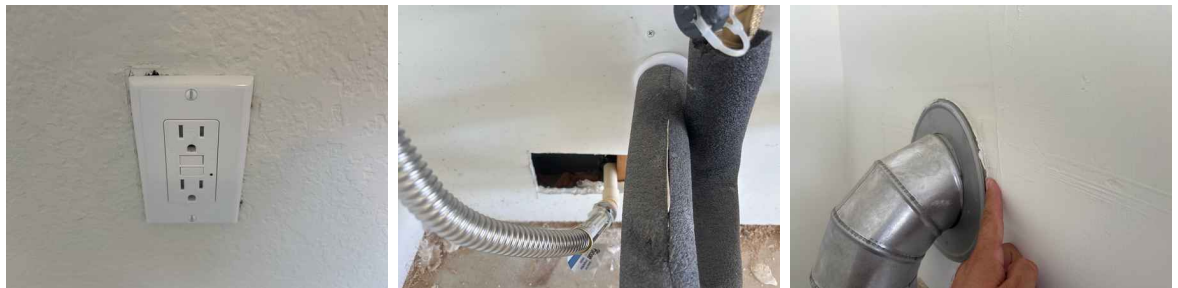
## 2: Voids in Wall Need Sealant

Voids were found in the wall where outlet is inserted and at water heater. It is recommended a qualified professional correct.

Recommendation: Contact a qualified professional.

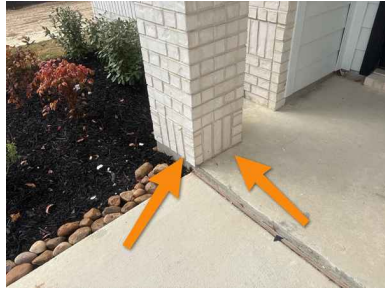
## 3: Missing Weep Holes

Weep holes are missing around front column. These help any moisture behind the wall system escape. It is recommended that a qualified, professional correct.

Recommendation: Contact a qualified professional.

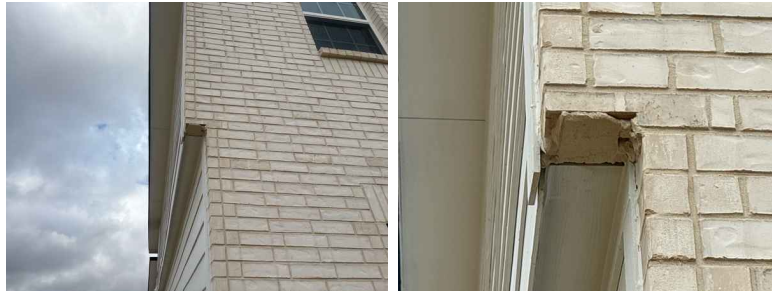
#### 4: Unsupported brick edge, no lentil or corbeling

Typically brick ledges cannot protrude further than 1/3 the thickness of the brick. Recommend corbeling or installing a lentil.

Recommendation: Contact a qualified professional.

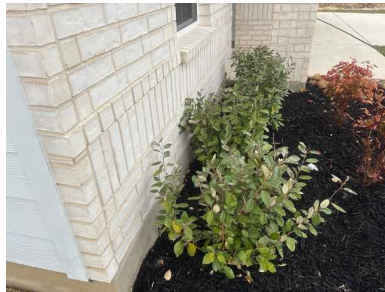
## 7: Vegetation contact

Vegetation contact can cause damage to walls or create conducive conditions for wood destroying organisms. Recommend trimming back.

Recommendation: Contact a qualified professional.

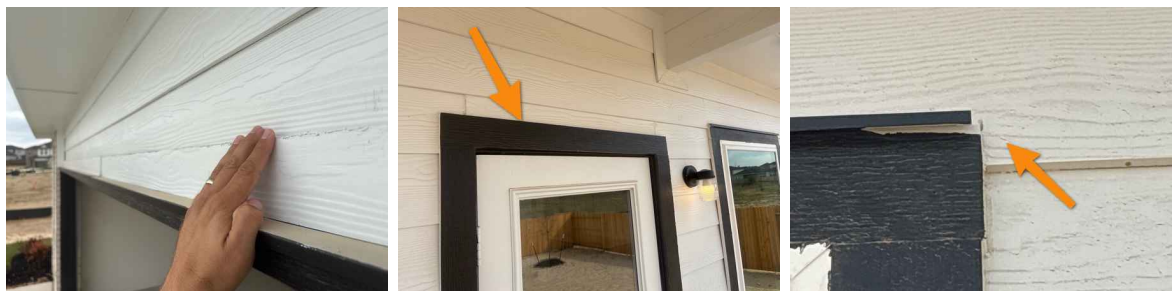
## 8: Horizontal flashing at uppermost horizontal trim

Horizontal flashing or z flashing was not present over the garage and rear exterior door. On some windows, z flashing did not extend to the ends of the horizontal trim. Z flashing shed water away from the penetration created by a door or window.

Recommendation: Contact a qualified professional.

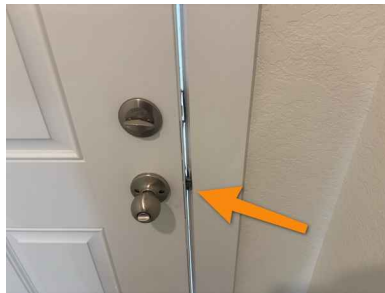
**1: Doors Need Adjustment**

Doors rub, hit frame, or needs adjustment. Recommend adjustment as needed. Observed in multiple doors throughout the home such as :

Recommendation: Contact a qualified door repair/installation contractor.

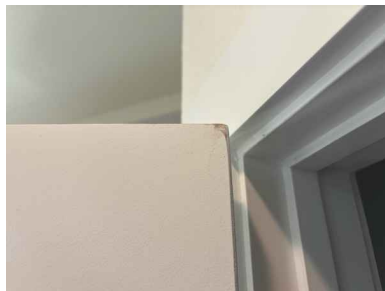
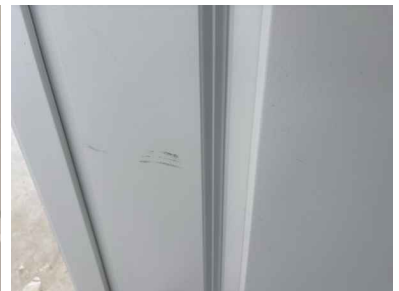
**2: Cosmetic**

Some cosmetic observations were found on the garage exterior door. Recommend a qualified, professional, evaluate, and correct.

Recommendation: Contact a qualified professional.

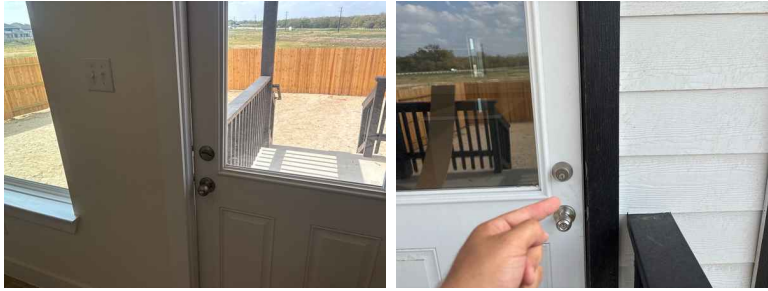
**3: Noticeable Gap**

Noticeable gap between rear exterior door frame and door. Recommend a qualified professional to correct.

Recommendation: Contact a qualified door repair/installation contractor.

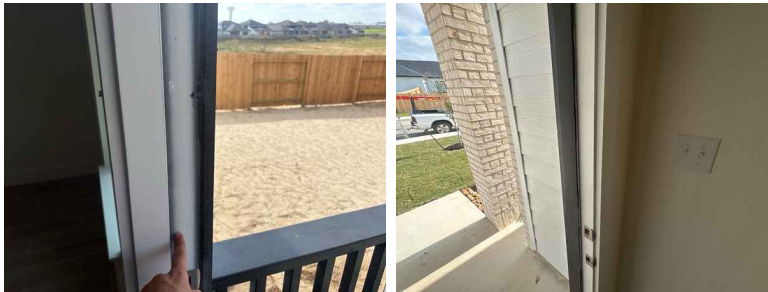
#### 4: Weatherstripping Insufficient

Door is missing standard weatherstripping. This can result in significant energy loss and moisture intrusion. Recommend installation of standard weatherstripping.

Recommendation: Recommended DIY Project

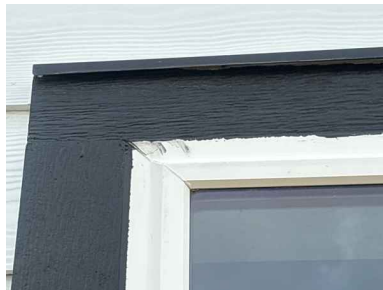
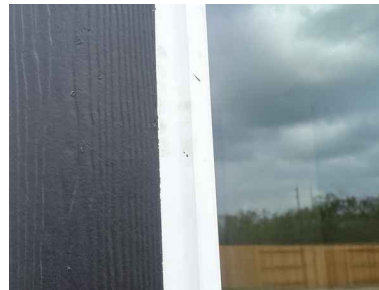
Paint and other construction debris was observed on window exterior. Recommend that a cleaning service evaluate and correct.

Recommendation: Contact a qualified cleaning service.

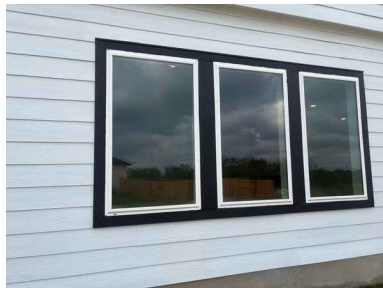
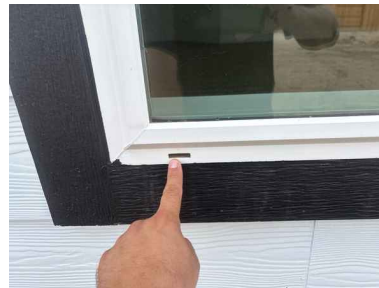
**2: Missing weep hole covers**

Right side

Recommendation: Contact a qualified professional.

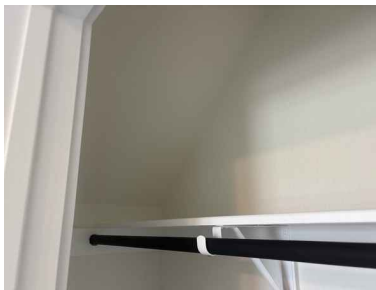
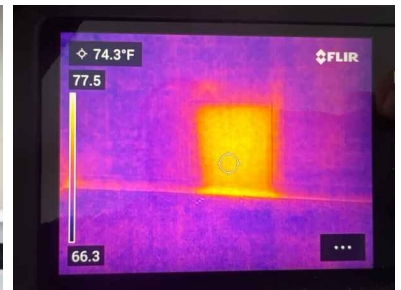
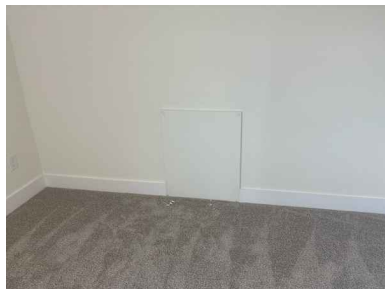
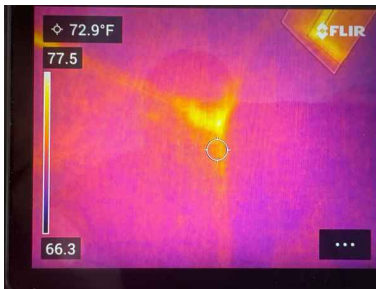
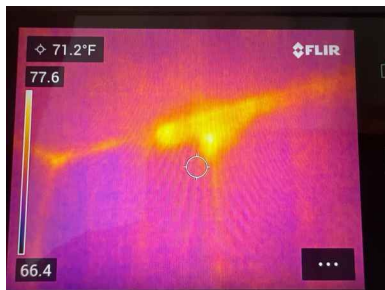
### 1: Thermal Image

This is not a Certified Thermography Evaluation. Tools are simply used to identify heat loss or variance in surface temperature. If insulation is present, it is not performing as intended.

Using a FLIR thermal device:

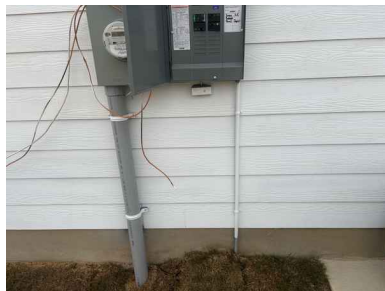
Ground rod not visible at grade. This does not suggest the system is not grounded; we just cannot see the ground rod. Sometimes other methods of grounding are necessary.

Recommendation: Contact a qualified electrical contractor.

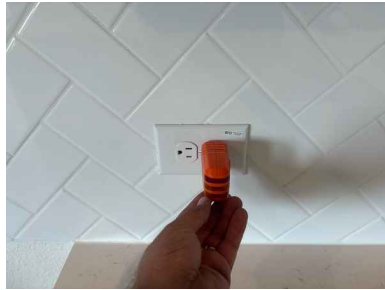
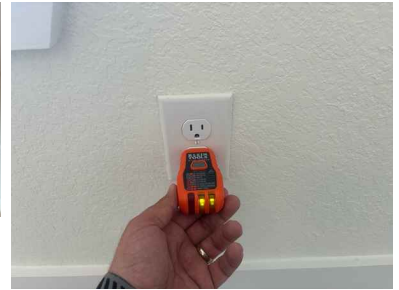
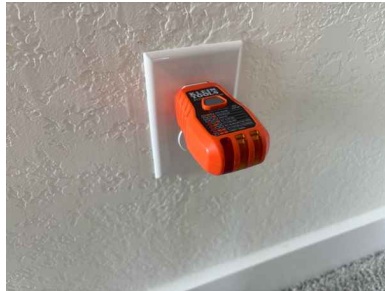
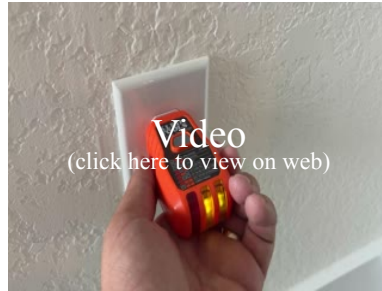
#### 1: Loose Receptacles

Loose receptacles found throughout the house. Recommend an electrician to ensure they are tight to prevent them from coming out.

Recommendation: Contact a qualified electrical contractor.

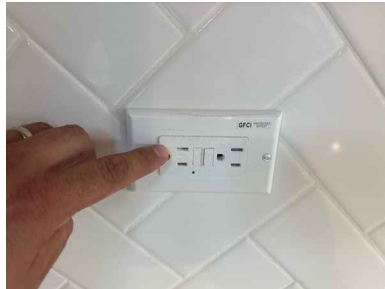
## 2: Minor construction debris on outlet

Kitchen gfci

Recommendation: Contact a qualified professional.

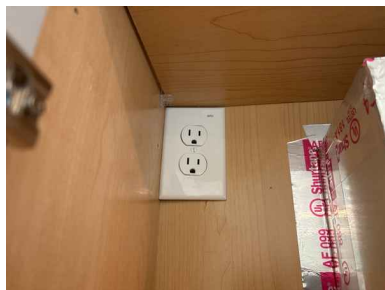
## 3: Range exhaust outlet, not fully flush to wall

Recommendation: Contact a qualified professional.

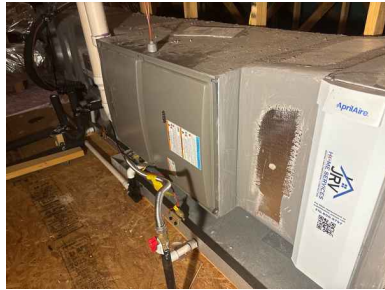
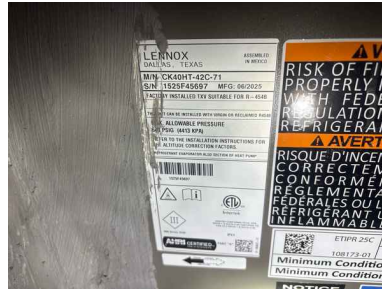
The unit was heating at the time inspected.

*The Internal components such as coils were not observed, accessible, or visible. Recommend coil cleaning and servicing by licensed HVAC professional. :*

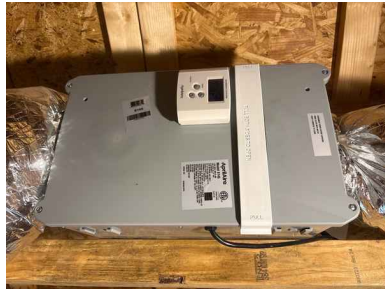
*Comment:* Yes -

Filters located in attic at the fresh air make up and main unit.

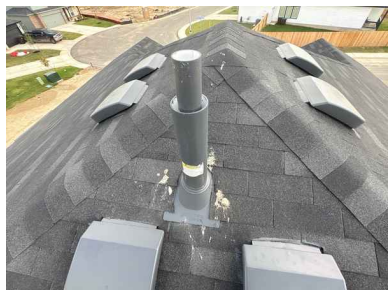
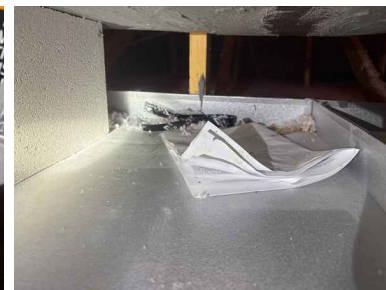
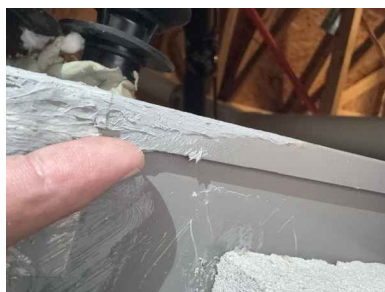
#### 1: Furnace/Air Handler

Missing rain cap on vent

Leaking at penetrations

Leaking at side of air handler cabinet

Recommendation: Contact a qualified professional.

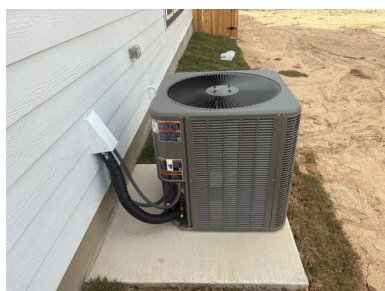
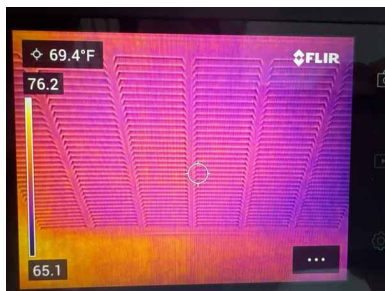
The unit was cooling at the time of inspection

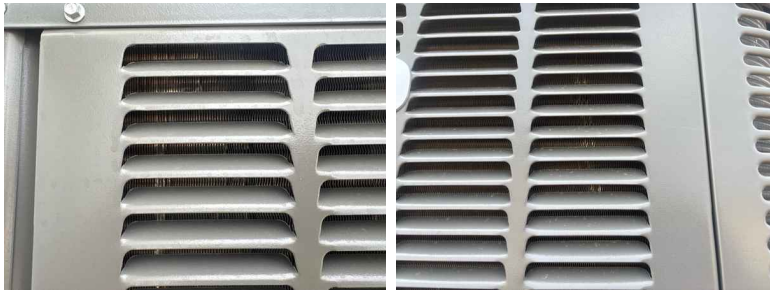
**1: Handling or impact damage at exterior condenser fins**

Recommend maintaining and raking by a professional.

Recommendation: Contact a qualified professional.

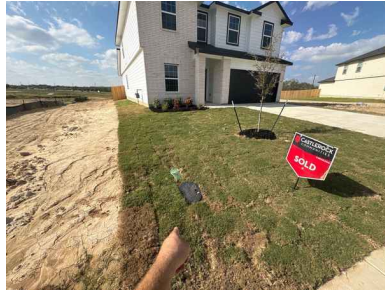
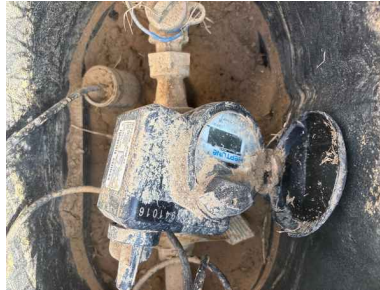
*Location of Water Meter: Front Left Side*

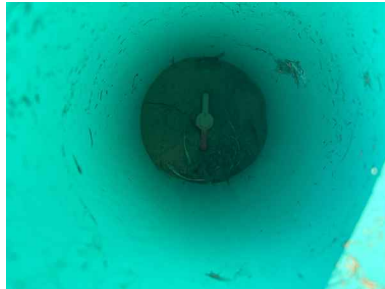
*Location of Main Water Supply Valve : Front Side by Meter*

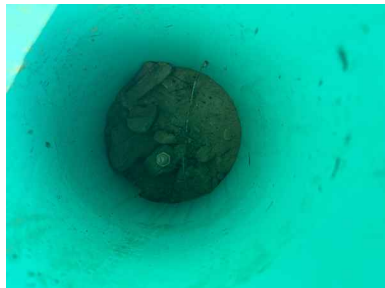
*Pressure Reducing Valve Observed::*

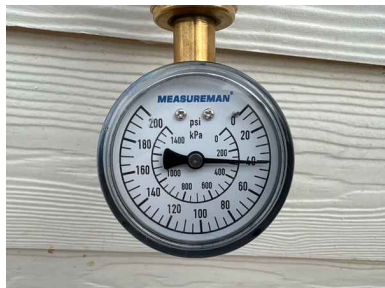
*Static Water Pressure Reading: 41*

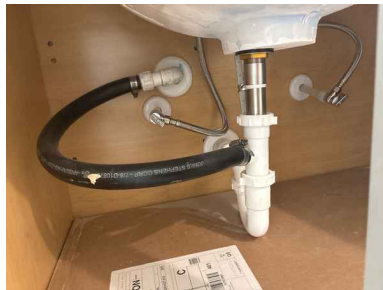
### 1: Kitchen

Previous signs of moisture

Recommendation: Contact a qualified professional.

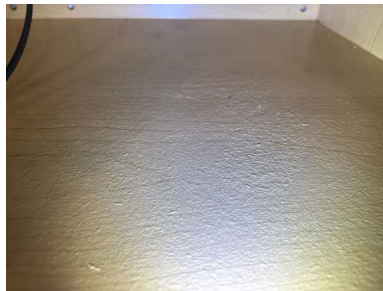
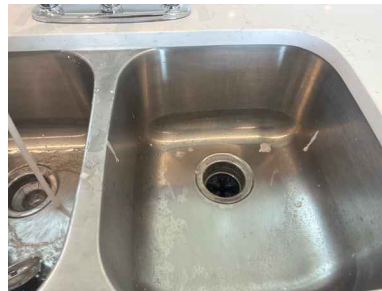
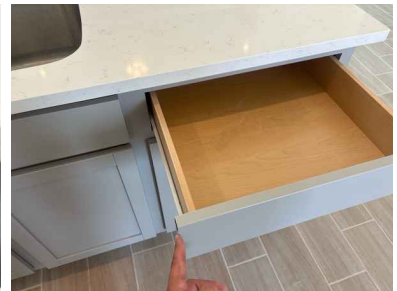
Cabinetry vinyl peeling on drawer face

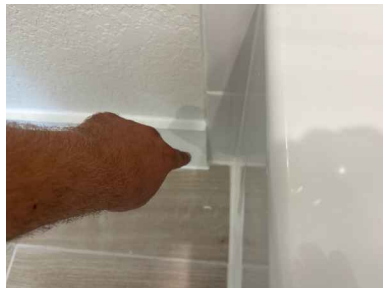
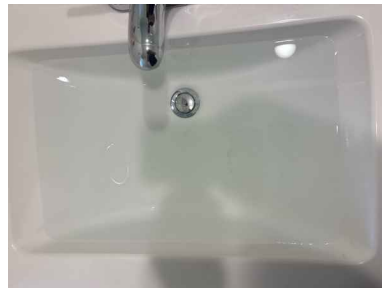
Previous signs of moisture

Recommendation: Contact a qualified professional.

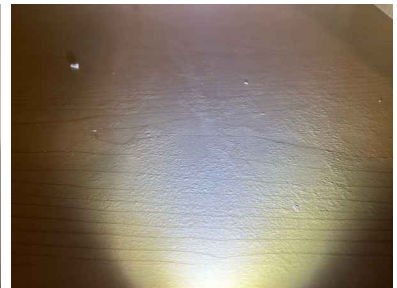
### 2: Common Bathroom

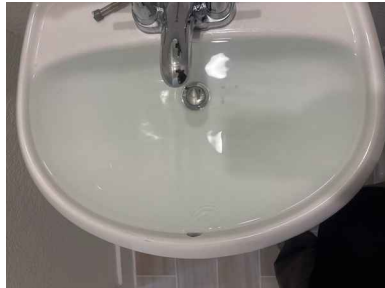
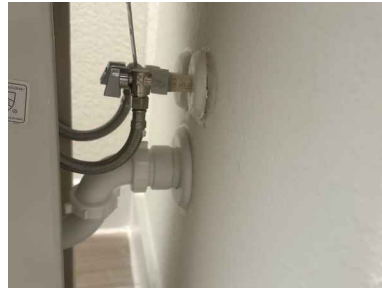
Overflow drain in sink slow

Recommendation: Contact a qualified professional.

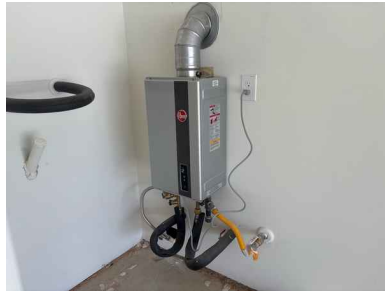
The unit was heating at the time of inspection.

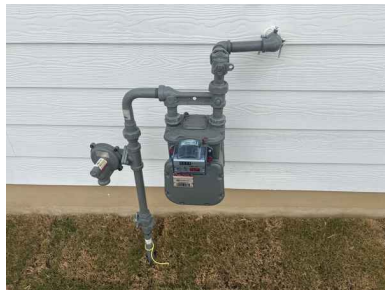
*Location of Gas Meter:* Front Left Side

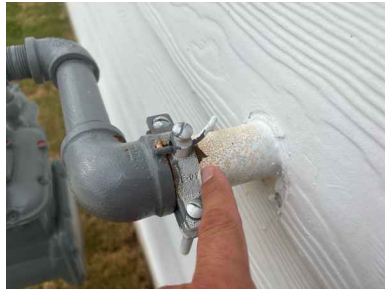
**1: Exposed/Rusted Pipe**

Recommendation: Contact a qualified professional.

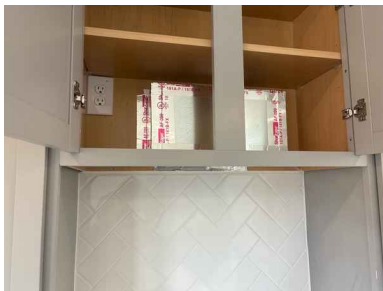
- ☒ ☒ ☒ ☐ **C. Range Hood and Exhaust Systems**  
*Type of Exhaust::* Plumbed for Exterior  
*Range ventilation duct present only:*  
 Range vent was not present. Only the duct was installed at time of inspection. it was only visually inspected as we could not test for leaks. Work in progress.

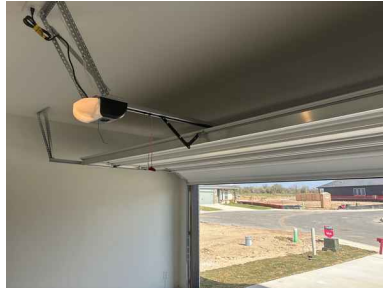
Garage door mechanism operates when actuated but door does not go up and down because it will not lock back in to the track. Recommend correction. Found like this upon arrival.

Recommendation: Contact a qualified professional.
