# FLYING V PROPERTY INSPECTIONS

# TREC REI 7-6

# 1234 Main Street La Vernia TX 78121

# PROPERTY INSPECTION REPORT FORM

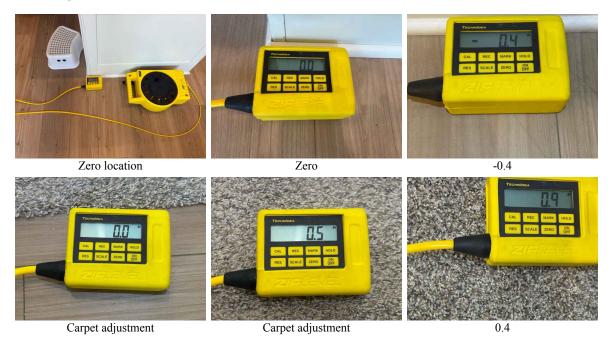
Random elevations using a ZipLevel Pro 2000 were taken. We did not find any concerns with slope or deflection. The foundation appears to be performing as intended.

In this inspector's opinion the foundation was performing as designed at the time of inspection. There were minor indications of settlement. There was no noticeable movement noted in the accessible attic space of this structure.

SUGGESTED FOUNDATION MAINTENANCE & CARE - Proper drainage and moisture maintenance to all types of foundations due to the expansive nature of the area load bearing soils. Drainage must be directed away from all sides of the foundation with grade slopes. In most cases, floor coverings and/or stored articles prevent recognition of signs of settlement - cracking in all but the most severe cases. It is important to note, this was not a structural engineering survey nor was any specialized testing done of any sub-slab plumbing systems during this limited visual inspection, as these are specialized processes requiring excavation. In the event that structural movement is noted, client is advised to consult with a Structural Engineer who can isolate and identify causes, and determine what corrective steps, if any, should be considered to either correct and/or stop structural movement.

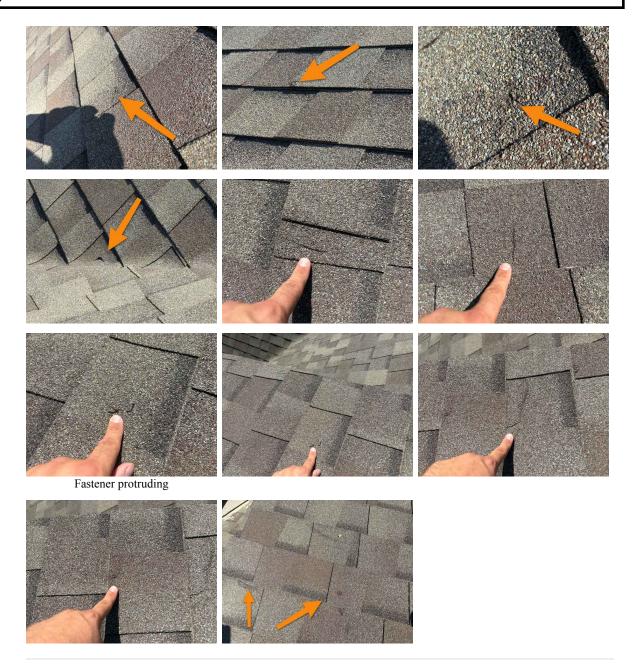
2: Exposed Nails

Exposed nails were found to not be sealed, leaving them exposed to rust. Recommend a qualified roofer to seal and correct.

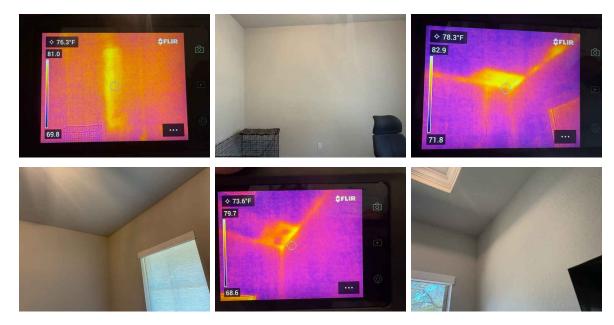
Thermal Image:

Temperature anomalies were found in various rooms in the house. If there is insulation in the observed areas they were not performing as intended at the time of inspection.

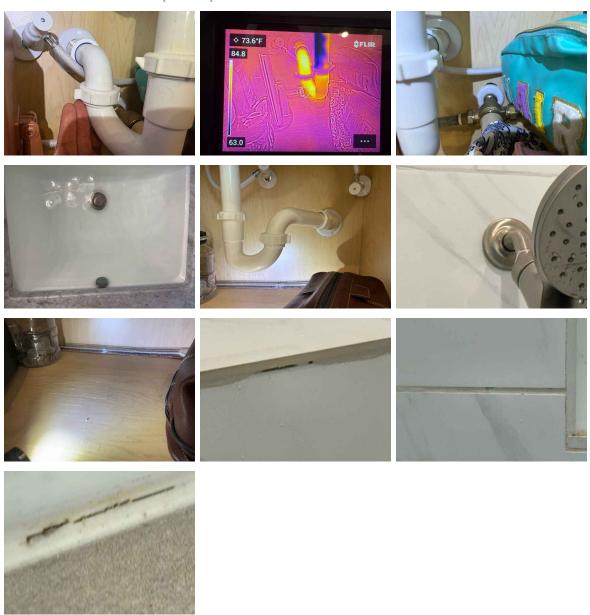
- The right side sink that has the primary ac drain condensates.
- previous signs of moisture right side sink.
- penetrations in back board should be sealed.
- right side sink over flow slow to drain.
- sealant and gout improvements needed in shower.

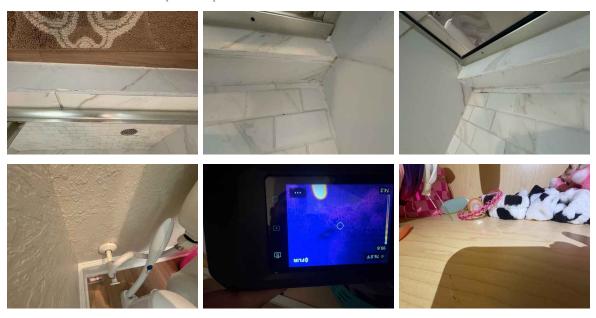
- -grout and sealant improvements to the shower
- Sealant and sheet rock behind toilet
- Sealant and cabinet backboard
- Leak on sink on left side.

Recommendation: Contact a qualified professional.

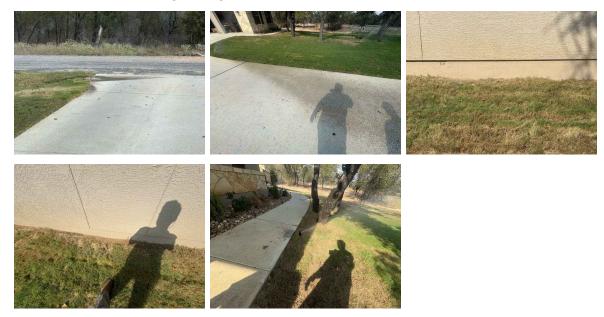
The water spray from the sprinkler system should be re-directed away from the structure and/or any fencing, decks, etc., to decrease the possibility of damage. Observed in zones:3-7

Recommendation: Contact a qualified professional.
