FLYING V PROPERTY INSPECTIONS

1234 Main Street  
La Vernia TX 78121

08/18/2026 9:00AM

# PROPERTY INSPECTION REPORT FORM

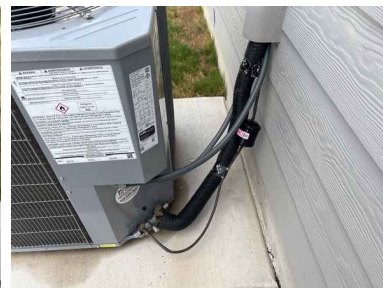
Section line was UV protected and in good condition
