FLYING V PROPERTY INSPECTIONS

1234 Main Street  
La Vernia TX 78121

08/18/2026 9:00AM

# PROPERTY INSPECTION REPORT FORM

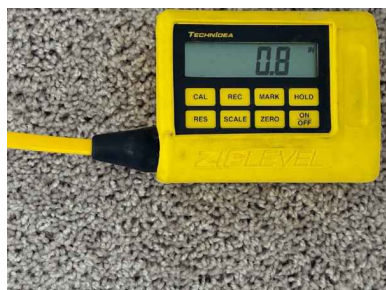
0.5 actual

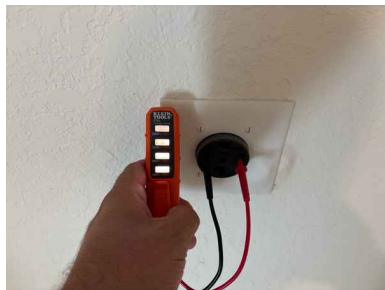
GFCI reset locations

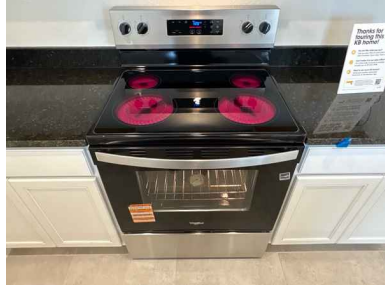
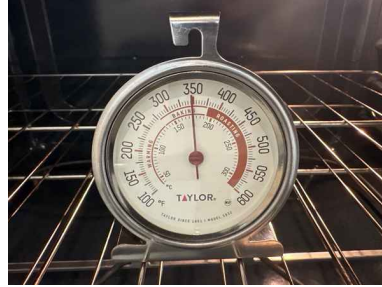
No significant problems observed at the time of inspection.

349° F when set to 350° bake

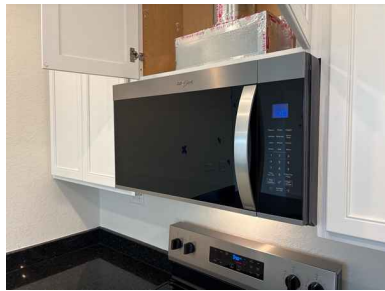
No significant problems observed at the time of inspection.

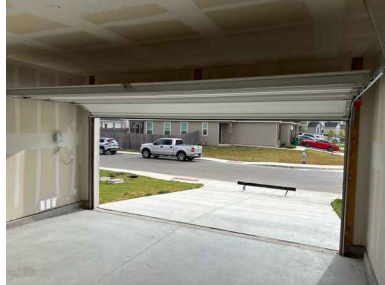
Garage door opening system not present, but manually operated as intended.
